Manhole Inspection Summary

Manhole # S11CC2015MH

Location Address: **2401 CREST RD** Cross Street: **GREENSPRING AVE**

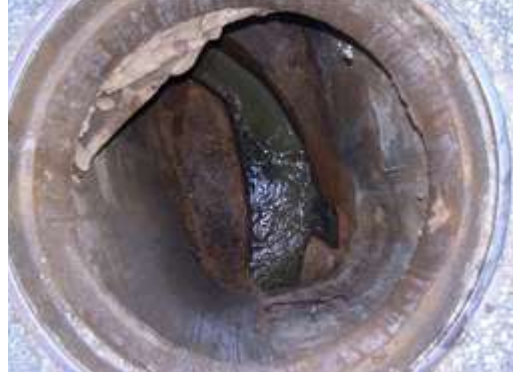
Top View

Corroded step. Evidence of surcharge - Bench debris.

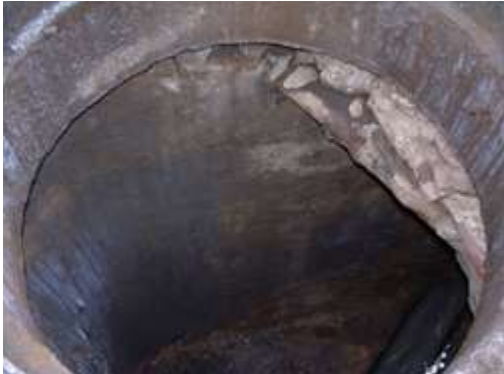
Defect

Frame leaks. Corbel deterioration and infiltration.

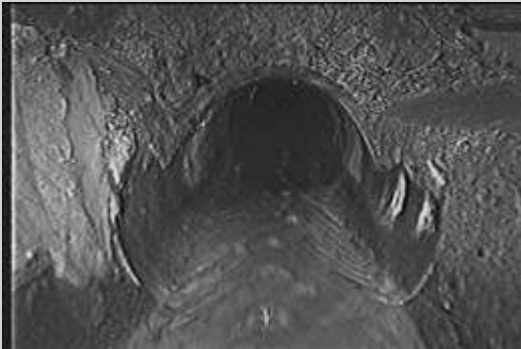
8 in. Circular Gravity Sewer Pipe Out @ 12 O'Clock

Barrel deterioration and infiltration.

Infiltration: **Evidence** Pipe Seal Cond: **Unknown**

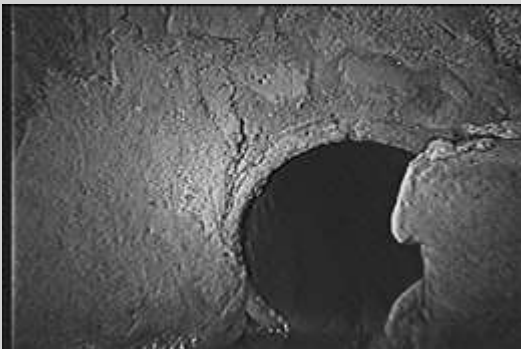
8 in. Circular Gravity Sewer Pipe In @ 6 O'Clock

Infiltration: **Evidence** Pipe Seal Cond: **Cracked**

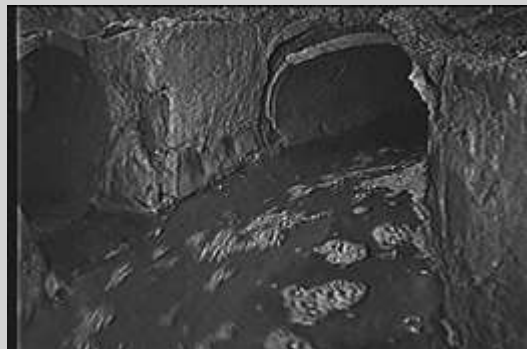
Pipe In @ 8 O'Clock

Channel deterioration.

Pipe Seal Cond: **Broken**
